# Cheshire Hall: The Future and Potential of a Loyalist Plantation Complex on Providenciales, Turks and Caicos Islands

**Donald H. Keith, Ph.D.**

**Occasional Papers of the Turks and Caicos National Museum**

**Number 3**

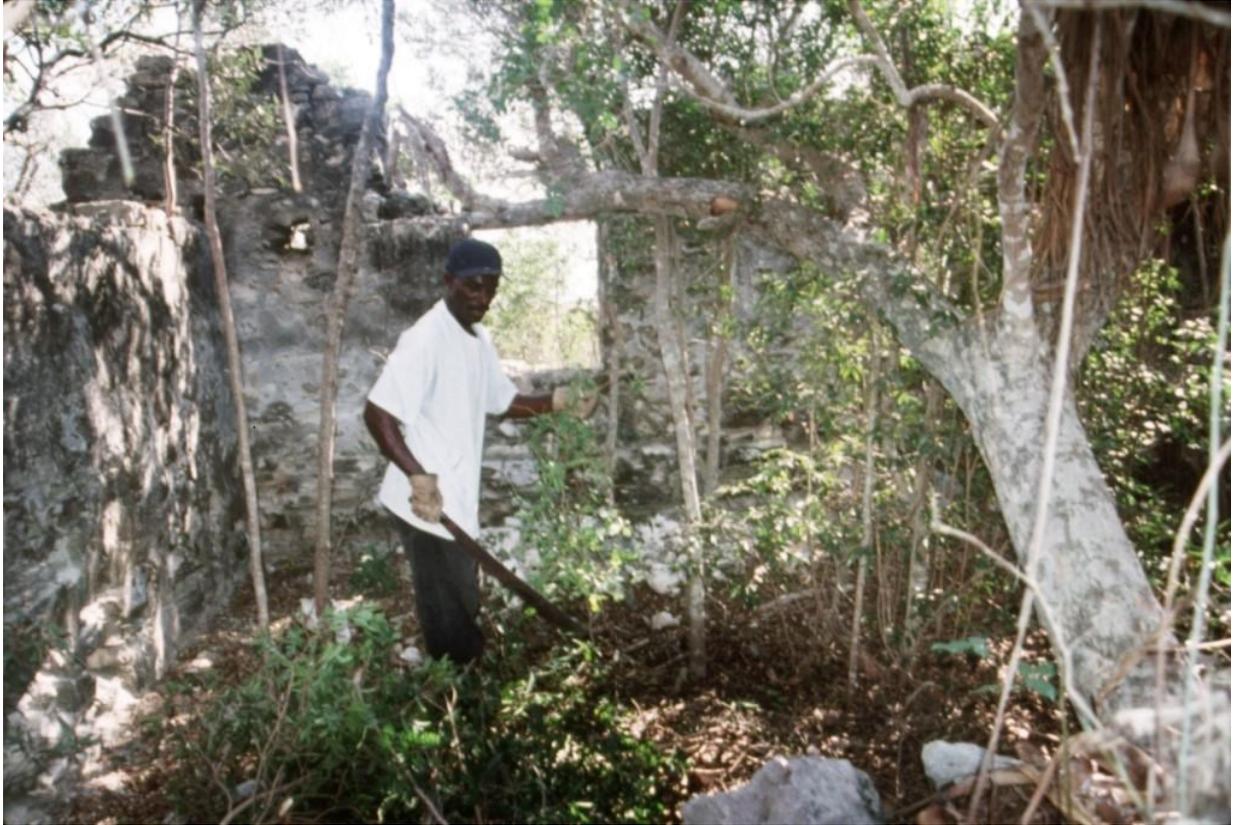
**Figure 1.** The “lost ruin”.

The four-person Ships of Discovery team spent the better part of one day clearing and photographing the “lost ruin” (Figure 1), located on the next hilltop to the south of the main Cheshire Hall complex, and approximately three days on the main site. We cleared a minimal of undergrowth on both sites in order to gain access to interiors of structures and to run measuring tapes between structures. We measured heights, lengths, widths of walls, doors and windows of every structure, and took scores of

surrounded by a substantial wall. Visitors to the site enter through the North Gate (Figures 5 and 6). The hill to the west of the complex is topped by a circular stone structure similar to Structures 6 and 7. The hill to the south is topped by the “lost ruin”, a well-made rectangular stone dwelling similar to but larger than Structure 1. It is probably that other structures once existed to the east and north of the main complex, but these have been eradicated by development. Bengt Soderqvist maintains that two small iron cannons that were once positioned between the Cheshire Hall complex and the sea were removed in the 1970s and taken to South Caicos to adorn the swimming pool of the Admiral’s Arms Hotel (now the School for Field Studies). The markings are still visible on these cannons, and they tell us that they are English-made, 6-pounders manufactured according to the Armstrong-Frederick pattern introduced in 1760. The crown and letter “P” engraved in the top of one of the guns indicates that the gun was “proofed” or test-fired, but was intended for civilian, not military, service.

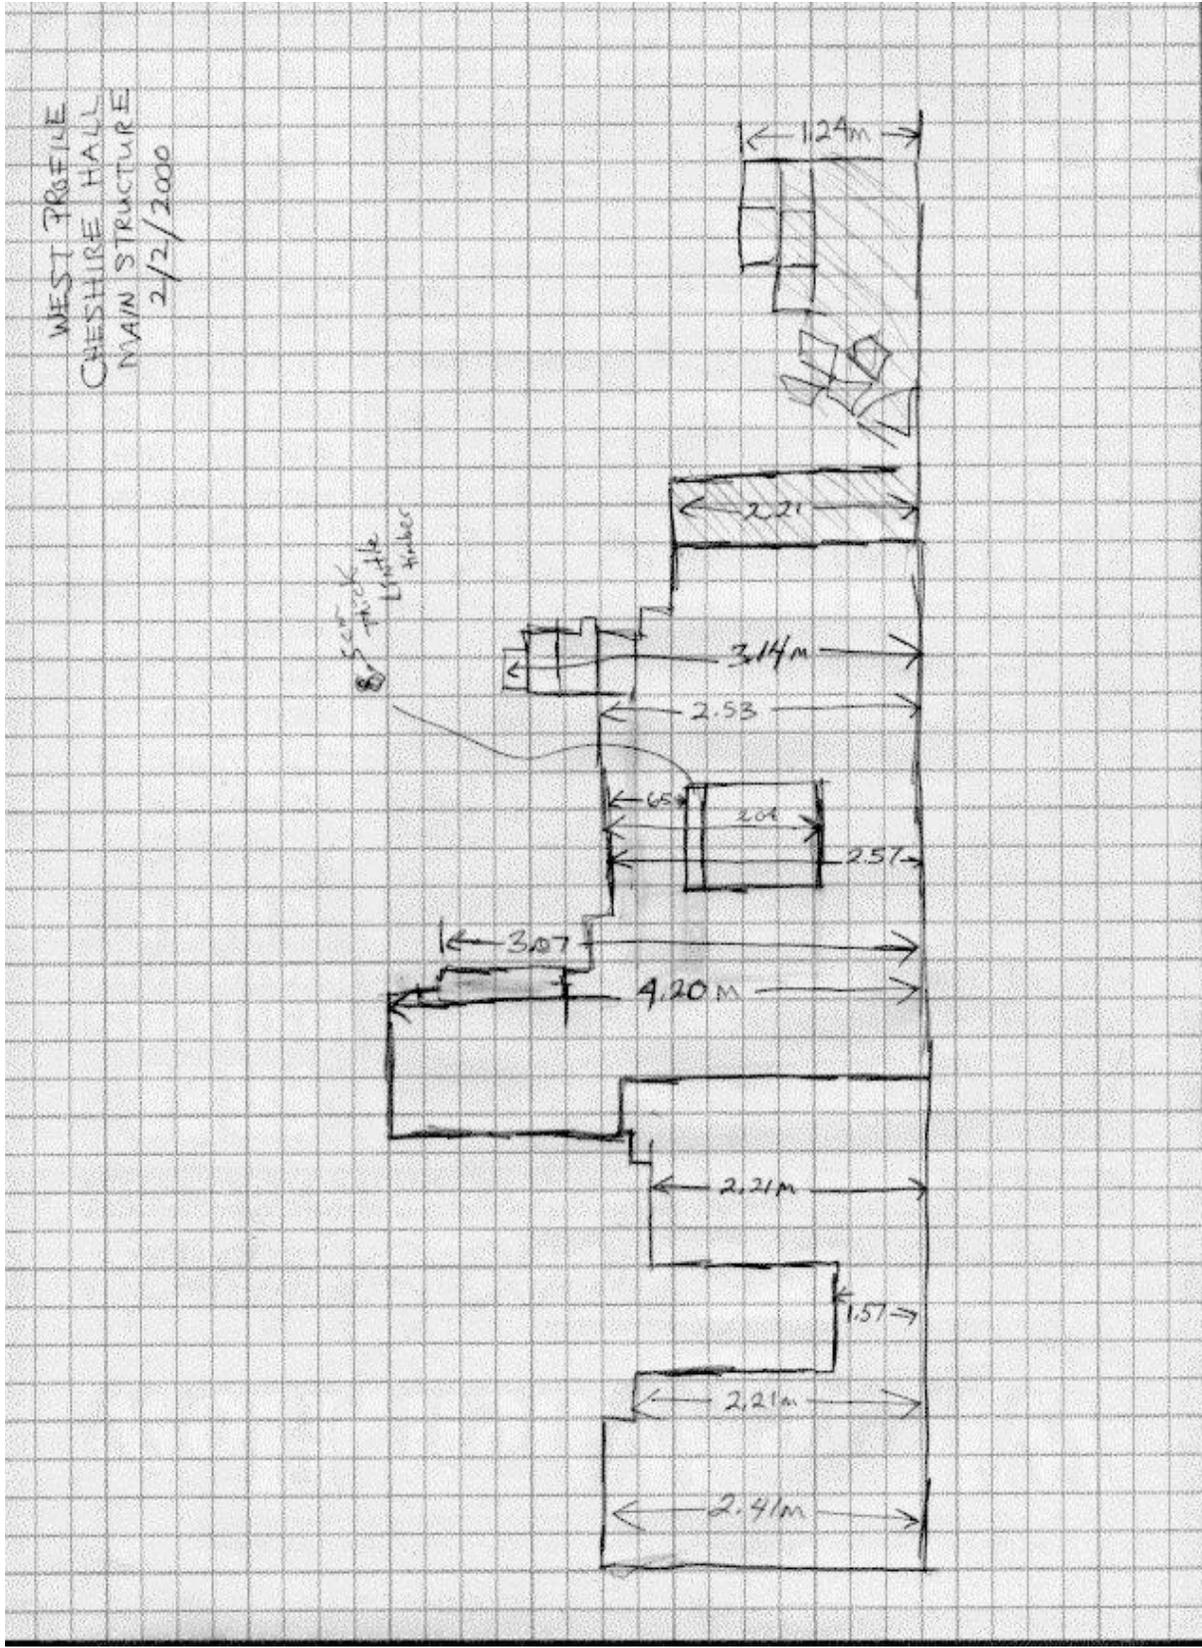
**Figure 2.** Sketch drawing of the west profile of the main structure (each square equals 25cm).

photographs to capture details and supplement our drawings (Figure 2). We measured the distances between structures and their orientations with respect to each other. We were not able to survey the site location into the national grid, but that can easily be done later using WGPS.

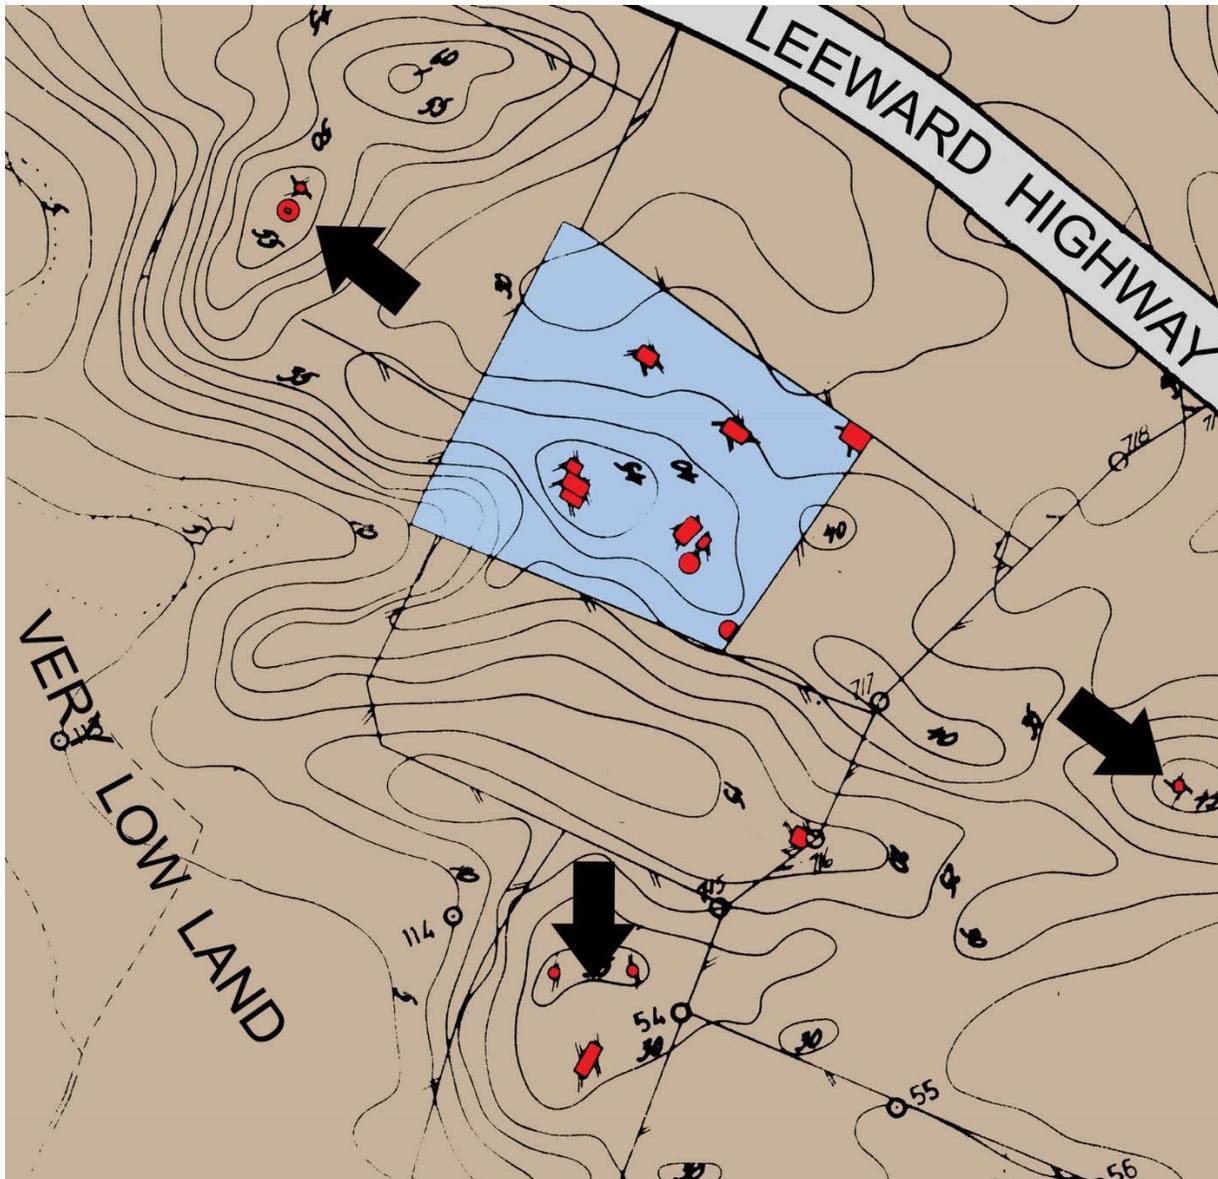
**Figure 3.** Provident Ltd. survey map showing Cheshire Hall ruins in the mid-1960s. Arrows point to outlying structures (red) associated with the central complex (blue).

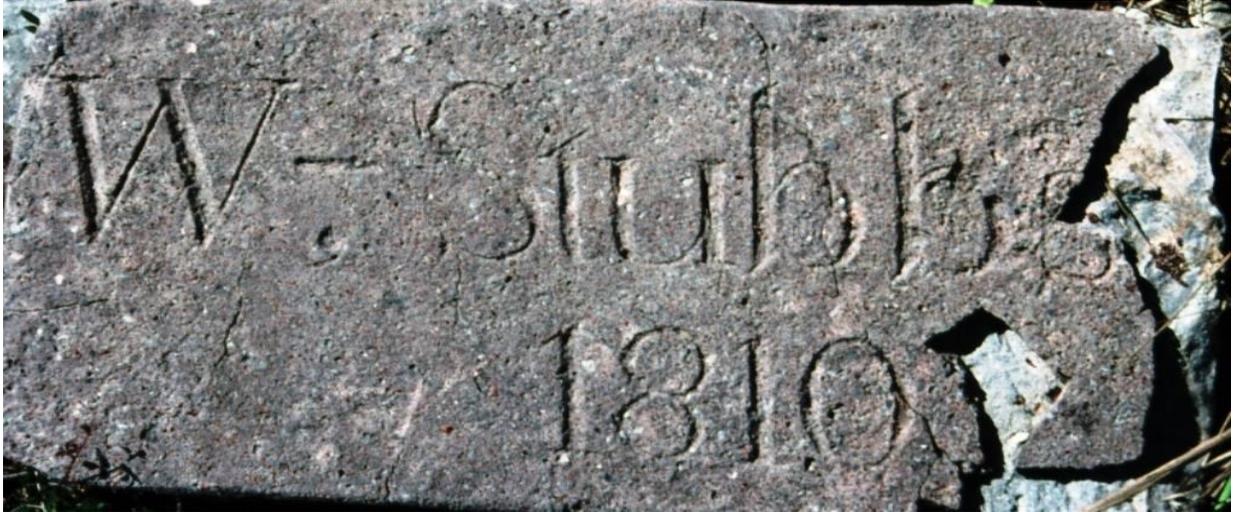
**Figure 4.** Inscription near the front steps of the Great House.

Conventional wisdom holds that the name Cheshire Hall was given to the plantation by one of its owners, Wade Stubbs, after the county of his birth in England. A cut stone bearing the inscription “W Stubbs 1810” (Figure 4) made in wet mortar, occupies a conspicuous place near the front steps of the Great House, but its original location is unknown. Previous owners may have included John Petty. The date of the beginning of construction is not known, but probably did not precede 1790. The ruins bear evidence of modification, repair, and re-use. It is not known when the plantation was abandoned by the Stubbs family, but it was probably close to the date of Wade Stubbs’

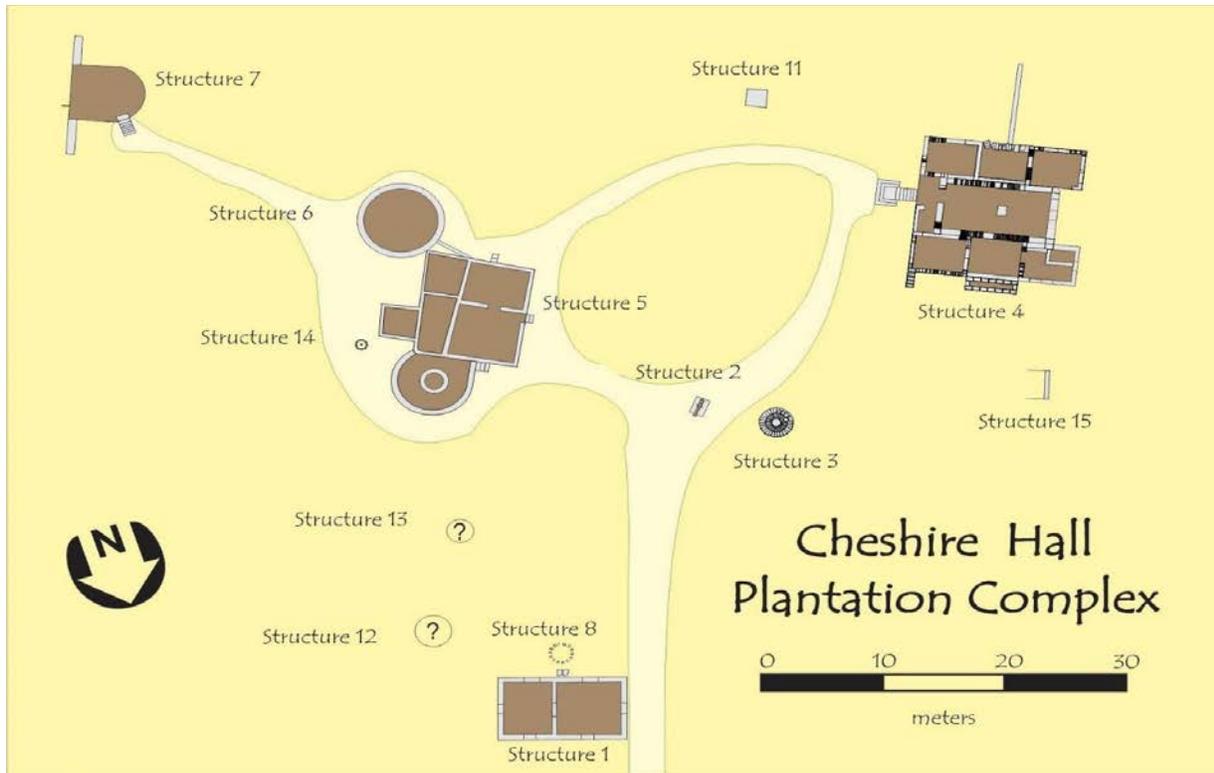
**Figure 5.** Measured scale plan of the Cheshire Hall main building complex.

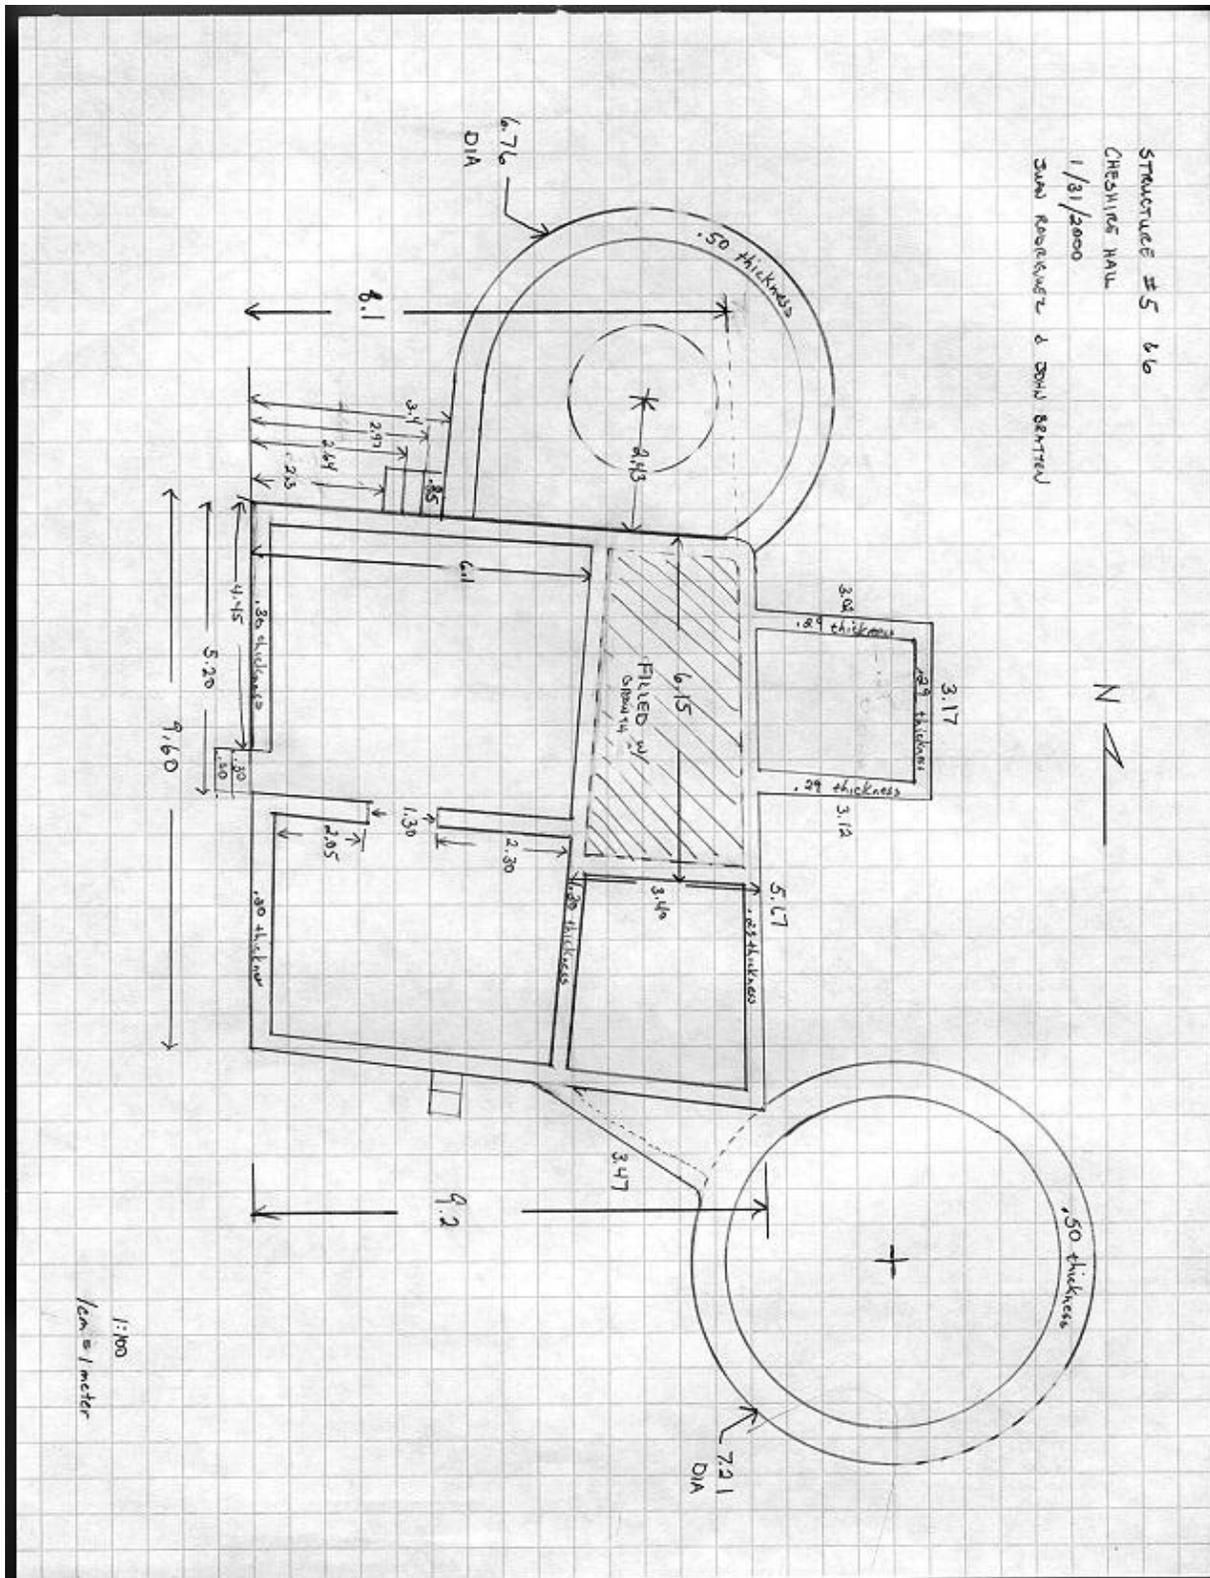
Figure 6. Measured plan of Structures 5 and 6.

Structures 5,6,7, and 14 appear to be elements of a processing facility for some sort of agricultural product, most likely cotton or sugar cane. The circular structures seem to have depressions in their centers which may have been occupied by a central beam or axle, or perhaps even a windmill. The fact that all the structures of this shape occur only on hilltops suggests that access to wind is important to their function.

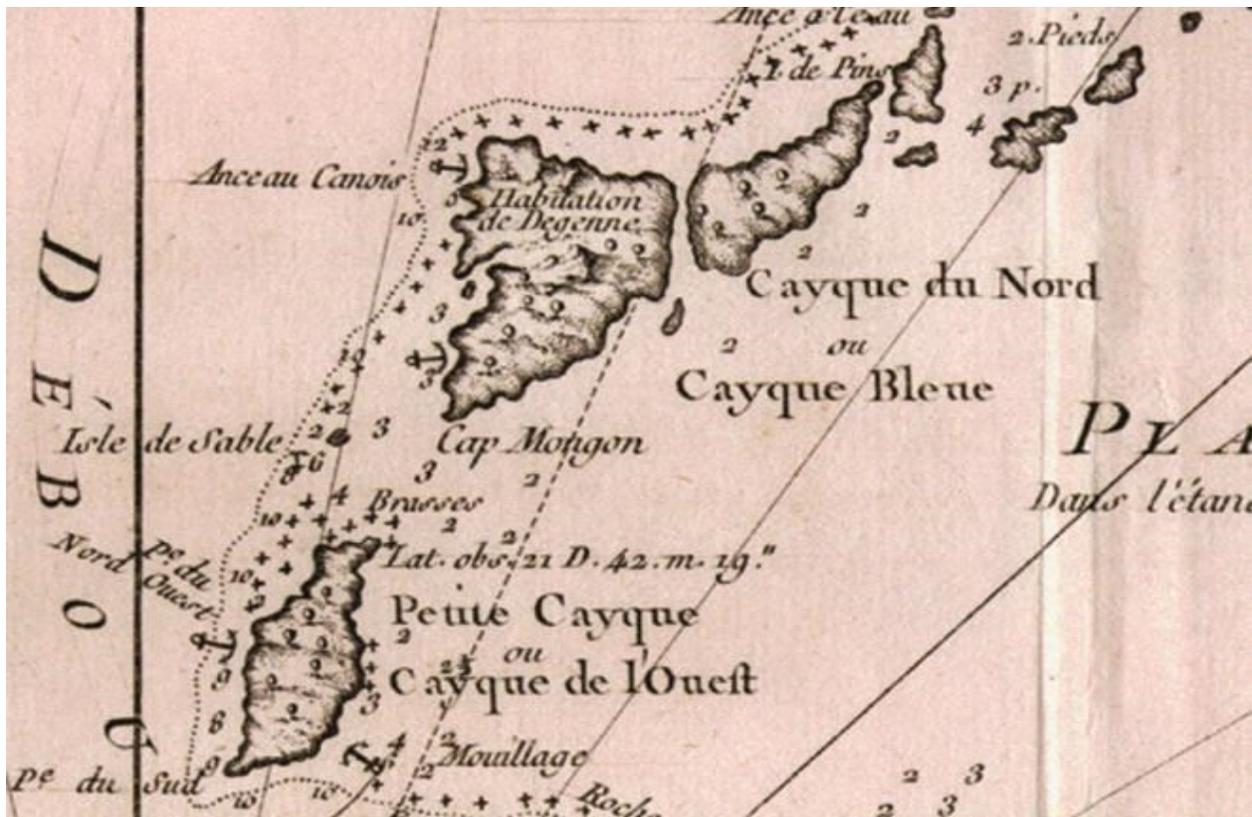
**Figure 7.** A French map from 1768 shows Providenciales as two islands. The waterway between them is approximately, where Cheshire Hall stands.

The reasons for locating the complex on this hilltop are not readily apparent. Early maps of Provo (Bellin 1768) appear to show it as two islands, with a waterway running from the north to the south in roughly the vicinity of Cheshire Hall (Figure 7). The maps are not sufficiently detailed to permit a definitive conclusion, but the land to the south and west of Cheshire Hall today is very low and subject to flooding. It is not inconceivable that the complex was sited to take advantage of a waterway providing access to both the Caicos Bank to the south and the Atlantic Ocean to the north. Dated inscriptions in stone on Sapodilla Hill, the

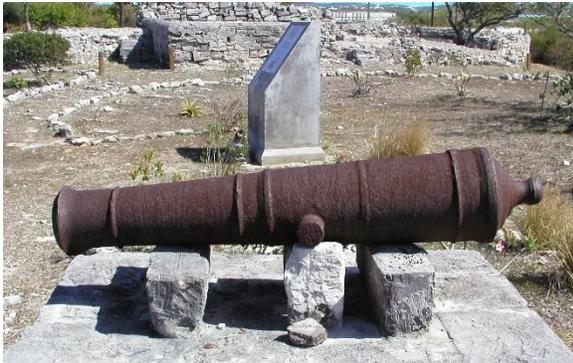
**Figure 8.** Small cannon on Cheshire Hall site.

Structure 2 is a modern plinth built to display an iron cannon. It probably did not exist in the past (Figure 8).

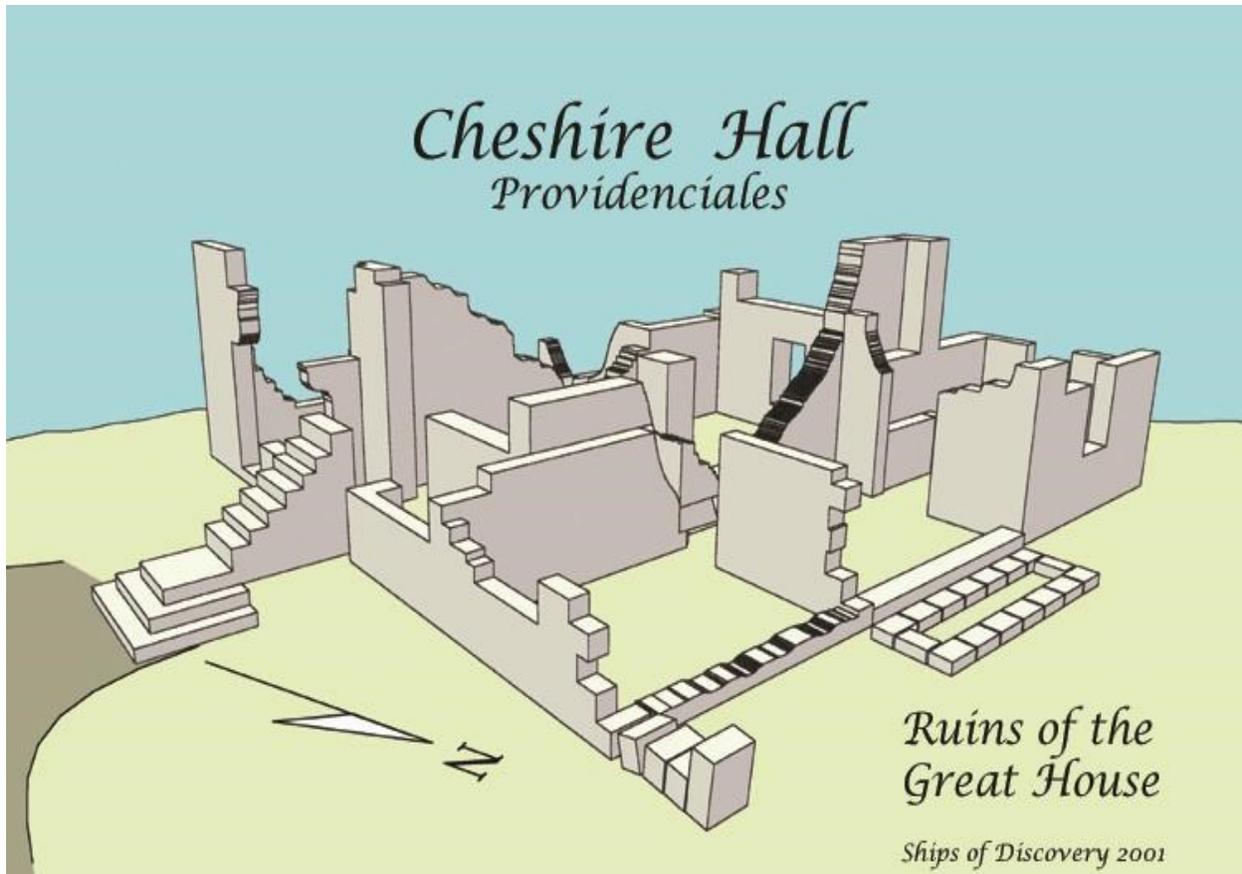
Structure 4 is the Great House, which must be one of the largest masonry dwellings in the Turks & Caicos Islands dating from the Loyalist period (Figure 9). Judging from the double walls between the large central room and those on either side to the north and south, the building was constructed in episodes –almost as three separate but abutting buildings. The main central structure has high surviving exterior walls, and where they have collapsed there are enormous mounds of debris. The north and south do not seem to be surrounded by enough debris to make second stories. There were at least seven rooms on the ground floor. The north face of the building may have had an open central entryway. The east face seems to have been the “formal entrance.” The south face may have been more private, opening onto a garden or

terrace. This side of the hill falls away more precipitously. The west face seems to have had only one doorway and two windows, but perhaps there was a balcony on the second floor of the central structure between the protruding arms of the north and south wings.

**Figure 9.** The Great House at Cheshire Hall Plantation.
