Report to the Department of Environment and Coastal
Resources of the Turks and Caicos Islands on the
Archaeological Survey of Endymion Rock, Nov. 27-
Dec. 13, 2007

**Report to the Department of Environment and Coastal Resources
of the Turks and Caicos Islands on the Archaeological Survey of
Endymion Rock
Nov. 27-Dec 13, 2007**

Submitted 31 January 2008

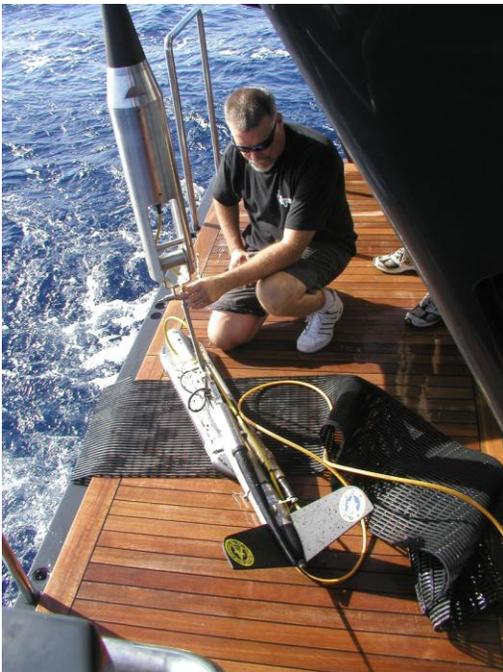
Figure 1. Preparing to deploy the side-scan sonar fish from the aft platform of *Plan B*.

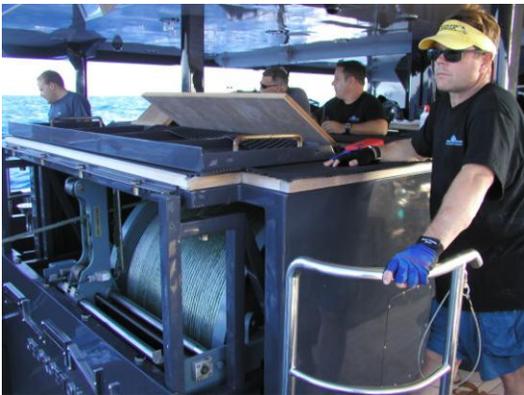
Figure 3. The remote-sensing team monitoring the instrument array during the deep water tow behind *Plan B*. The drum holds 10,000 feet of tow cable.

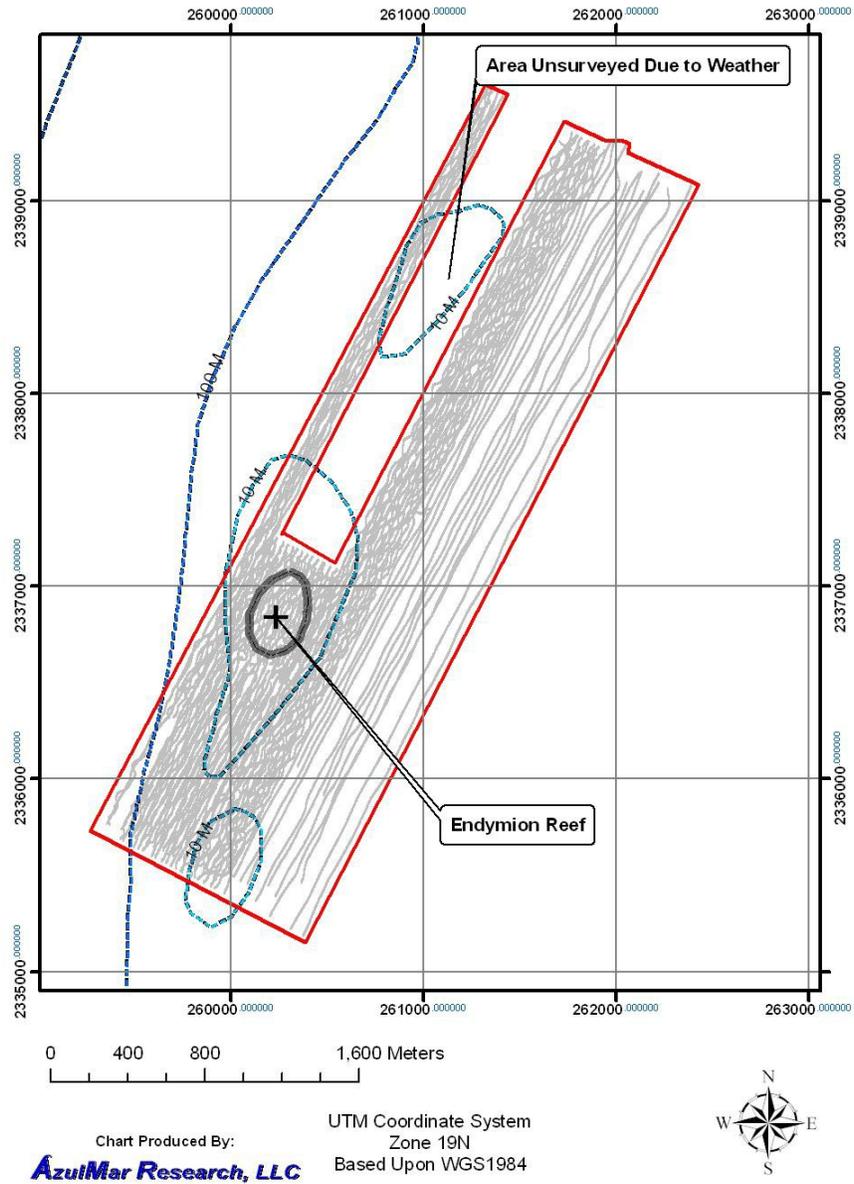
Survey Line Map

Figure 5. Survey track lines followed during the survey.

Endymion Rock is located in the Caribbean Sea on the southeastern end of the Turks Island Passage. The reef that formed Endymion Rock is the southernmost shoal of the Turks Island chain. The survey area lay directly over the top of Endymion Rock, extending out to deeper water in all directions. The area surveyed measured approximately 1250 by 4400 meters. Due to a weather system that prevented the completion of the survey, a roughly 2600 meter by 350 meter section of the survey box to the north of Endymion Rock was not completed (Figure 5).

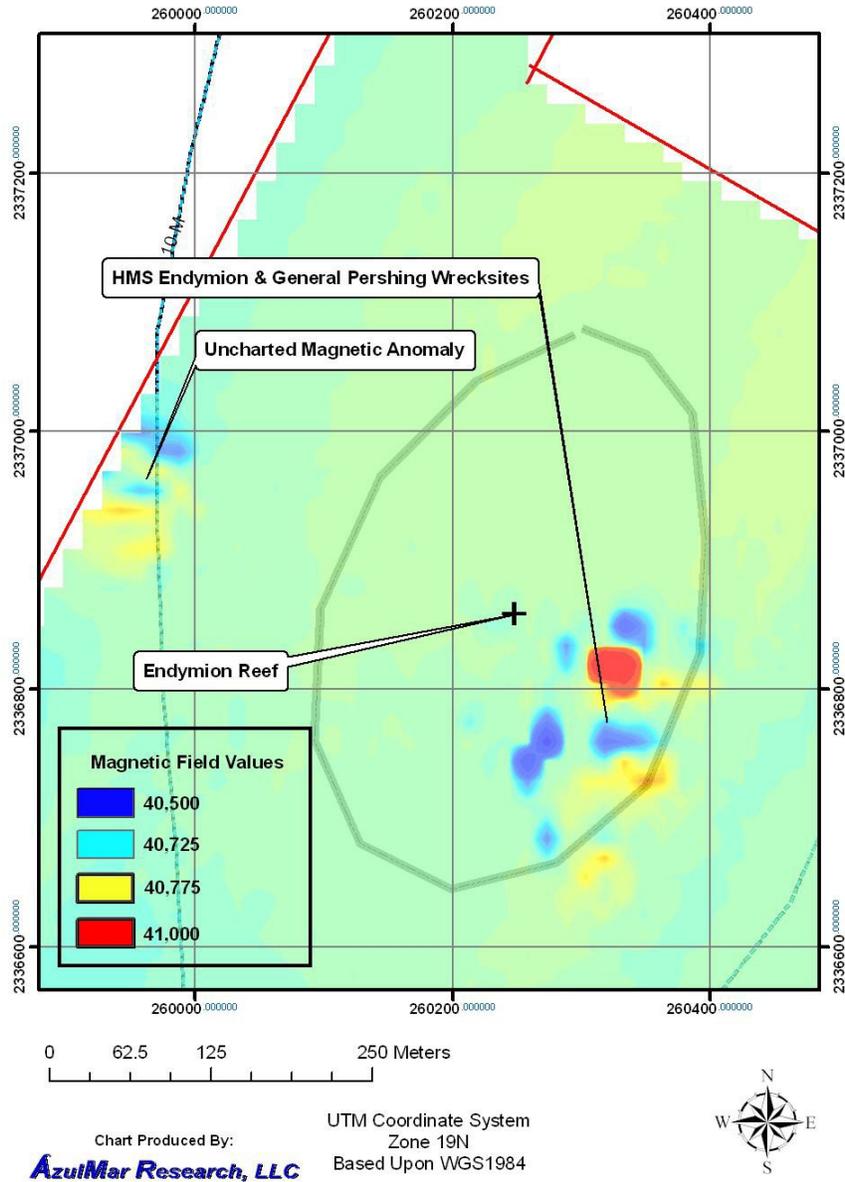
Magnetic Gradient Map

Figure 6. Magnetic map of the area immediately around Endymion Rock showing the two main concentrations of shipwreck debris.

The shallow water survey located two distinct remote sensing features, a large multi-component magnetic anomaly along the east side of the rock and a smaller multi-component magnetic anomaly with associated acoustic targets to the west of Endymion Rock. The large multi-component anomaly along the east side of the rock was confirmed by divers to be the intertwined shipwrecks of the HMS *Endymion* and the Companion Wreck. That anomaly is centered at 260304E / 2336780N and the area of magnetic influence measures approximately 220 meters by 130 meters (Figure 6). The anomaly consists of at least 9 dipolar or monopoly signatures and has a minimum magnetic reading of 40, 489 gammas and a maximum reading of 41, 457 gammas. Unfortunately, the side scan sonar was unable to detect much of the shipwrecks due to the significant heave that was induced

The multi-component anomaly to the west of Endymion Rock was centered at 259957E / 2336964N and covered an area measuring approximately 120 by 63 meters (Figure 6). This area is very close to the drop off on the western side of Endymion Rock. The anomaly consists of at least 4 monopolar and dipolar magnetic signatures with a minimum magnetic reading of 40,700 gammas and a maximum reading of 40,797 gammas. Side scan sonar data of the area shows 6 distinct objects protruding from the bottom (Figure 9). Those objects all had similar acoustic characteristics. They were all roughly 2-3 meter geometric objects that protruded from the seafloor 1-2 meters. The acoustic energy returned from them indicated that they were a very hard material like iron or steel. These anomalies were confirmed by divers to be large iron boxes with geometric shapes (Figure 10).

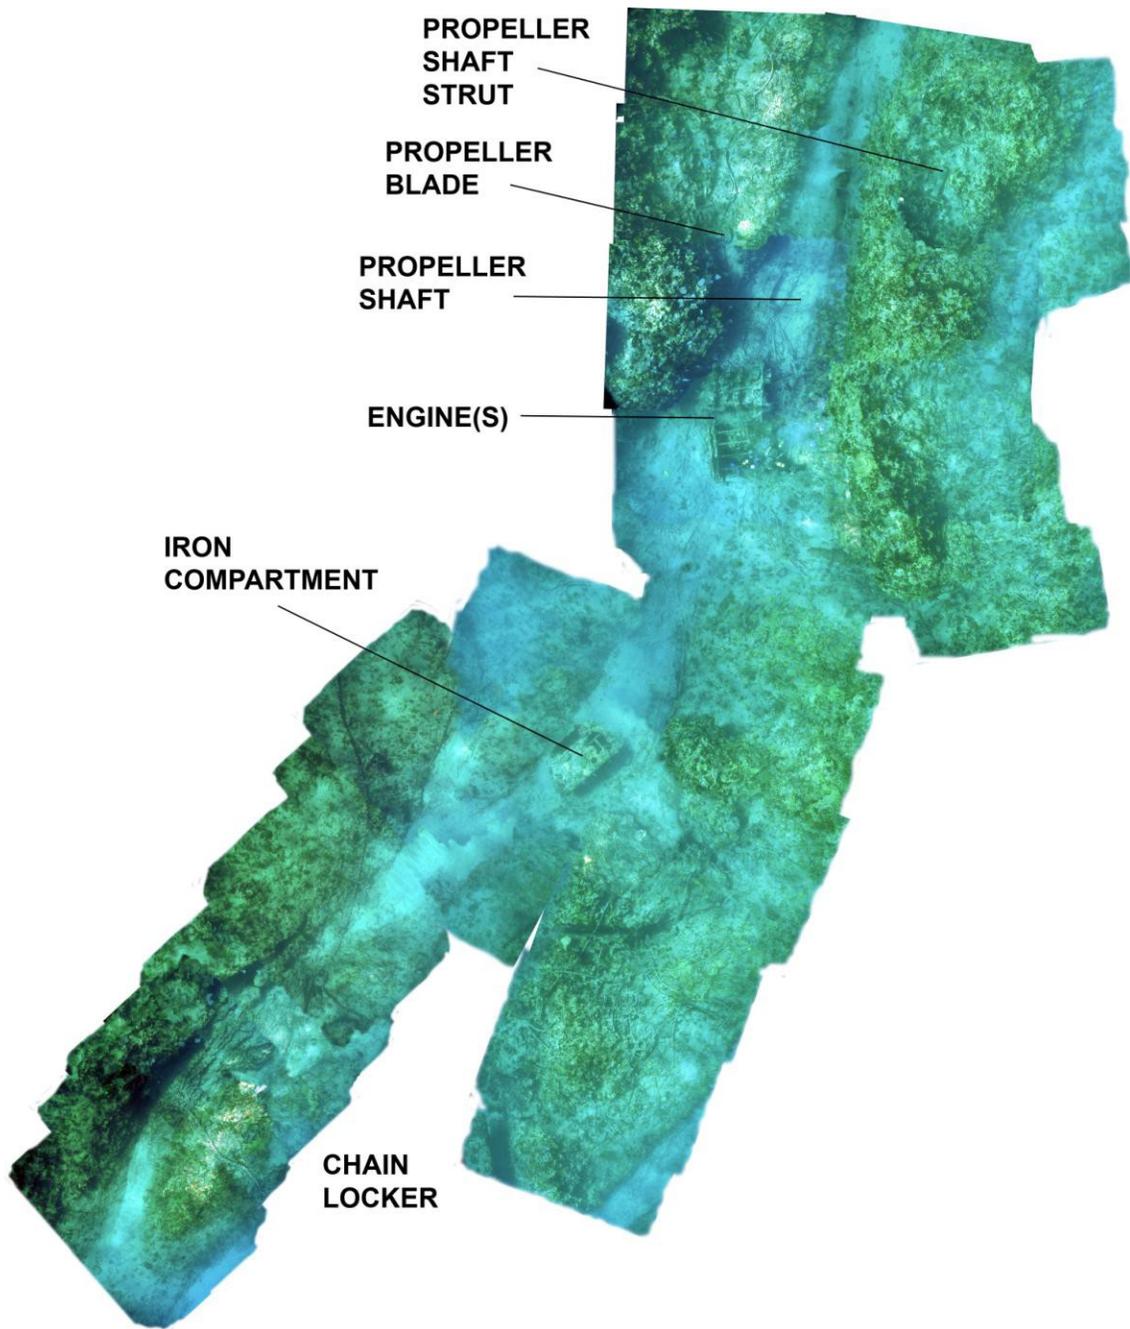
Figure 7. A rough photo mosaic of part of the Companion Wreck site with key artifacts identified.

lines. Due to parallax problems created by waves on the surface and the undulating shape of the seabed in a finger-and-groove coral reef environment, the mosaic cannot be used to measure actual distances between objects and features, but it can supply far more detail than a site sketch (Figures 7 and 8).

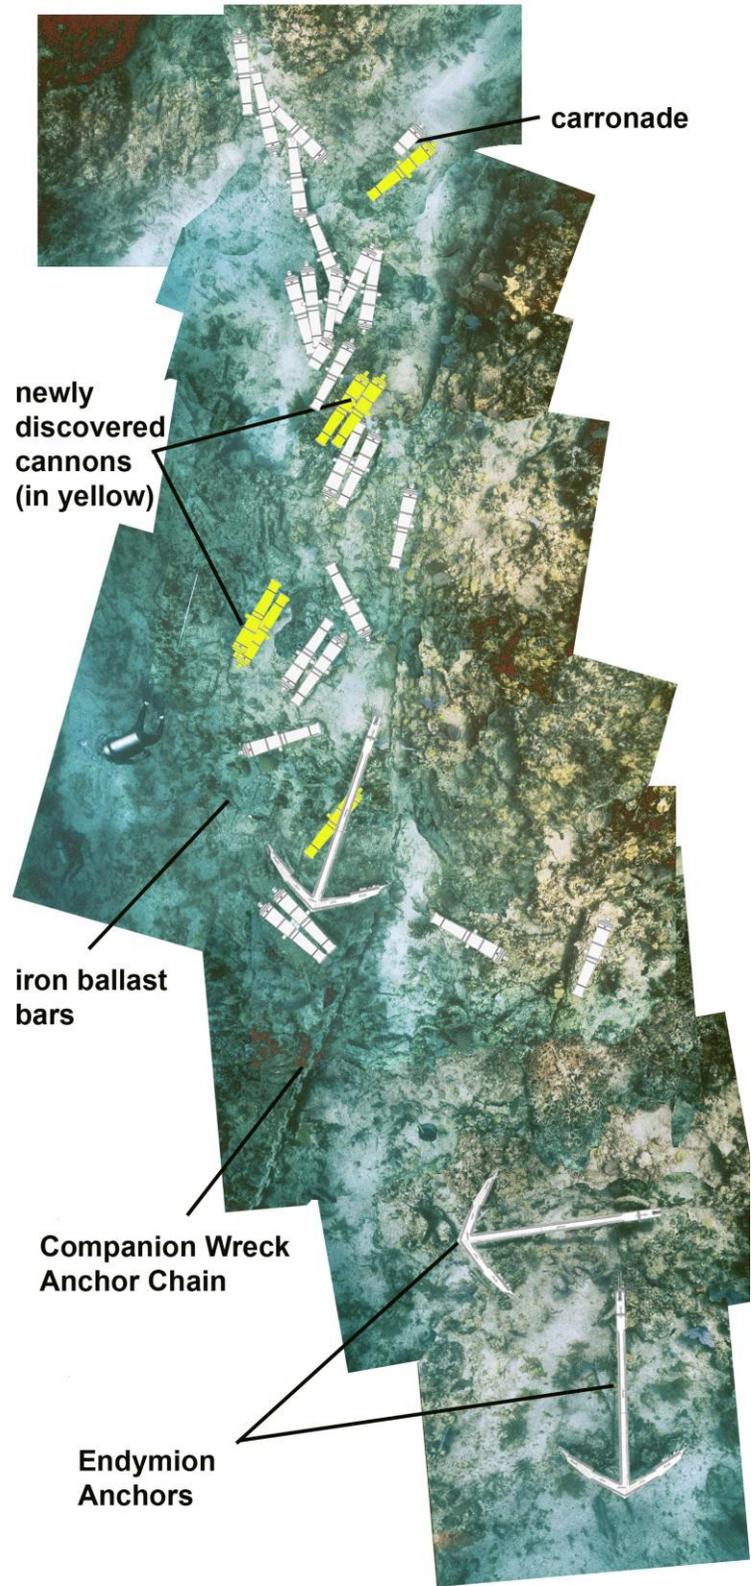
Figure 8. Photo mosaic of part of the HMS Endymion site with cannon and anchor templates positioned over the actual objects. Newly discovered cannons are in yellow.

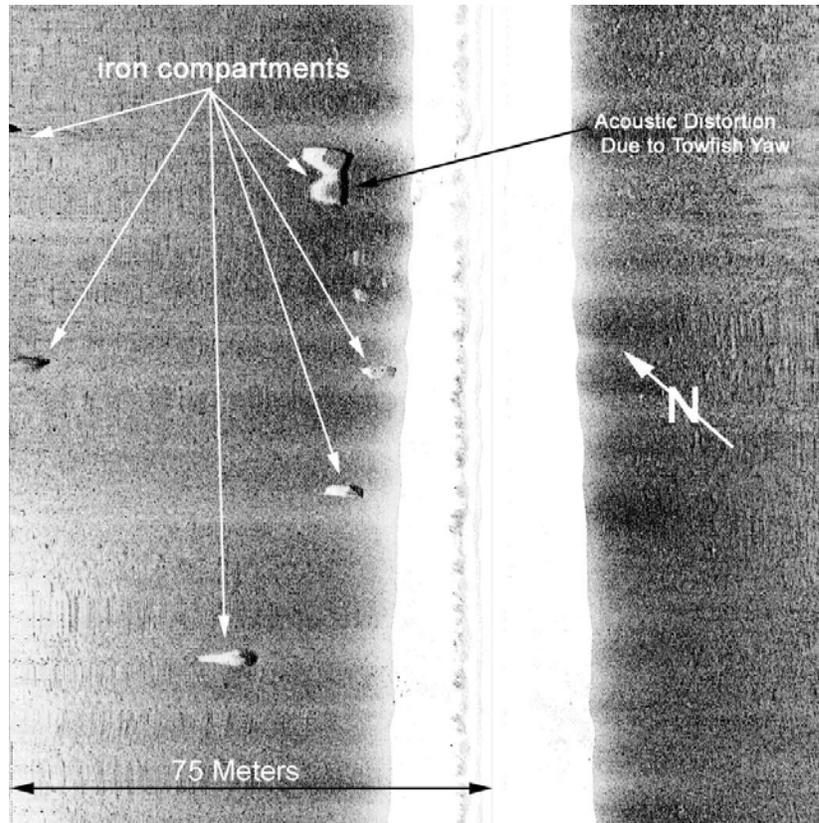
Figure 9. A section of the side scan sonar record showing six anomalies in 54 feet of water. The white acoustic "shadow" cast by each of the objects makes them stand out clearly. The anomalies are large, riveted, multi-faceted iron compartments such as below in Figure 10.

- Located magnetic and sonar targets that may represent additional shipwrecks near Endymion Rock (Figure 9).
- Produced an excellent photographic and video record of the condition of both shipwreck sites to serve as a “baseline” against which to compare future changes in the site brought about by natural or human agencies.

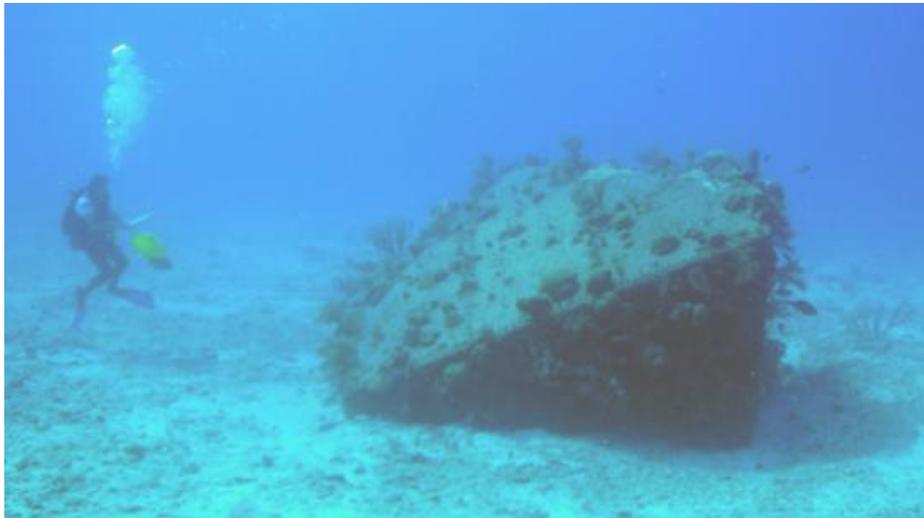
Figure 10. One of the group of four intact riveted iron compartments found at 259958 E, 2336960 N, several hundred meters to the West of the main site.

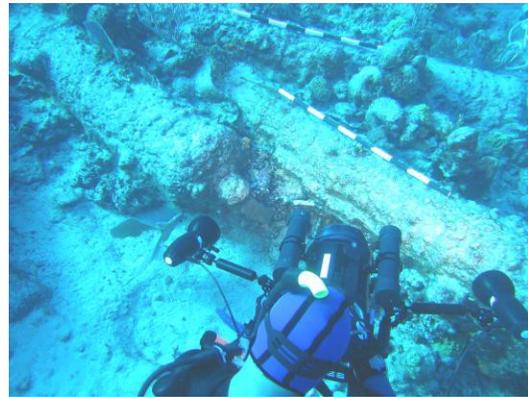
Figure 11. Cannons on the HMS *Endymion* site lie stacked one atop another making it impossible to see how many are present.

- Refined mapping of the Endymion Rock site and produced a photo mosaic of the Companion Wreck site for the basis of a site plan.
- Tentatively identified the Companion Wreck through analysis of the engine and other machinery on the site (Appendix II).
- Located and identified other shipwreck material near Endymion Rock.
- Identified 6 cannons not previously noticed on the *Endymion* site, and raised the possibility that most, if not all of the 44+ guns are still on the site (Figure 11).

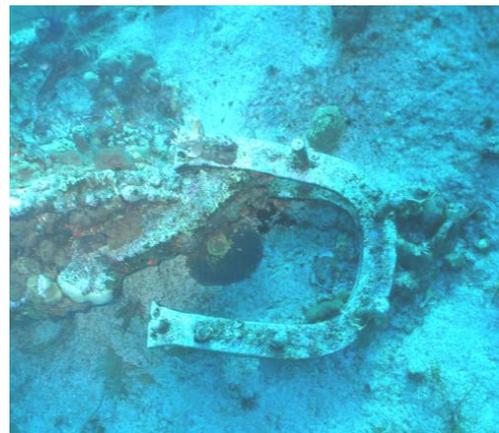
Figure 12. This large double-horseshoe clamp wedged beneath one of Endymion's anchors could easily be removed for museum display without disturbing anything else on the site.

- One of the large 18-pounder cannons
- One of the small carronade cannons
- One of the four anchors on the site
- The large bronze horseshoe clamp wedged under an anchor (Figure 12)
- One of the large iron ballast bars

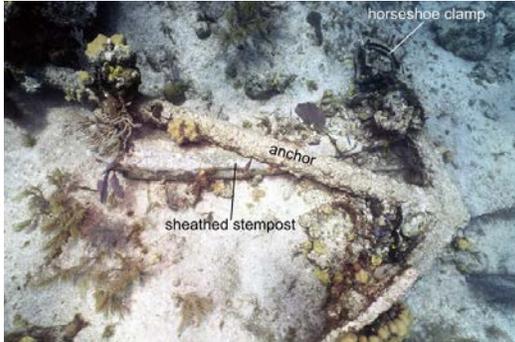
Figure 13. One of the four anchors of HMS *Endymion*. The shank is more than 16 ft long and the spread of the arms is about 10 ft!

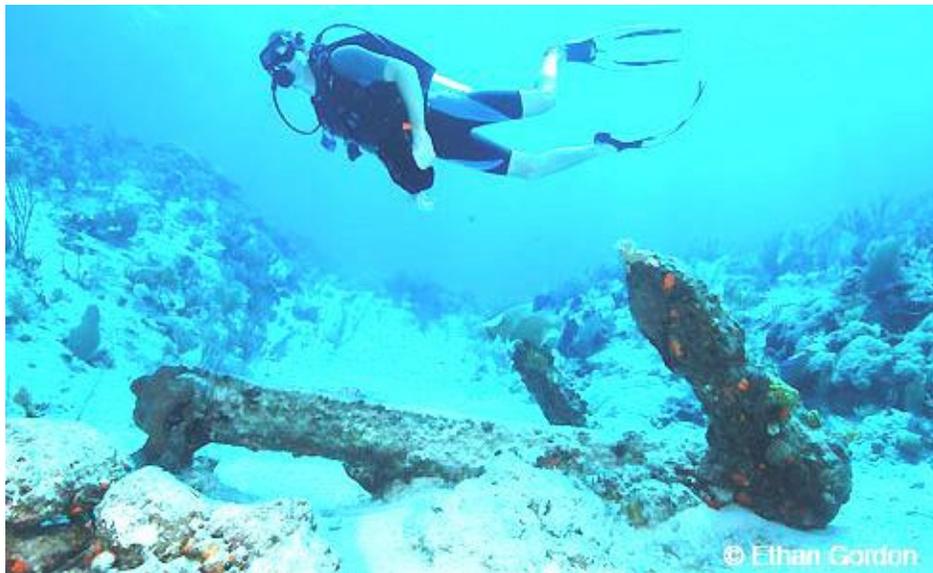
Figure 14. One of the four anchors of the Companion Wreck. Anchor is 8 ft long, 4.5 ft wide. Photo by Ethan Gordon.

- One of its four anchors
- Anchor chain
- The driveshaft and propeller
- An engine

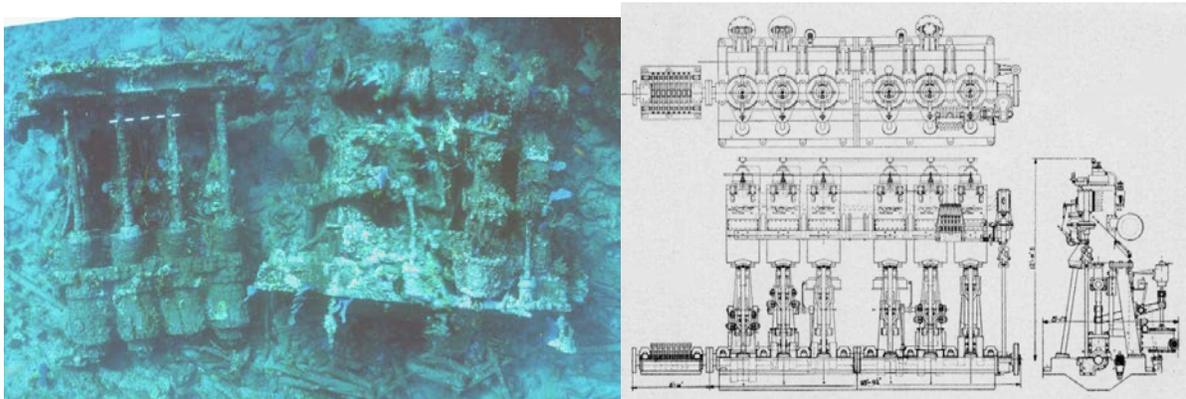
Figure 15. Left - the hot bulb oil (diesel) engine of the Companion Wreck. It has not yet been determined conclusively if it is a pair of 4-cylinder engines or a single in-line 8-cylinder engine. The enormous size of the engine(s) can be appreciated by comparing them to the meter-long black-and-white measuring sticks. Right - drawing of a hot bulb oil engine very similar to that of the Companion Wreck, but arranged in two banks of three cylinders rather than two banks of four cylinders. (Credit: <http://www.oldengine.org/members/diesel/Marine/Sumner/html>)

Raising and restoring an entire marine engine would be difficult and costly, but it has been done before (McCarthy 2000) and--at 14 ft tall, 10 ft wide, and 7 ft deep--it would make an impressive, one-of-a-kind exhibit!
